TEST REPORT

CTK Co., Ltd.	**CTK Co., Ltd.** 5 Dongbu-ro 221beon-gil, Cheoin-gu, Yongin-si, Gyeonggi-do, Republic of Korea Tel: +82-31-339-9970 Fax: +82-31-624-9501	Report No.: CTK-2024-00441 Page (1) / (15) pages

4. Test sample / Model : WALL & POLE MOUNT / SBP-400WMW

7. Test Standard (Method) used : NEMA 250-2014
Enclosures for Electrical Equipment (1000 Volts Maximum)

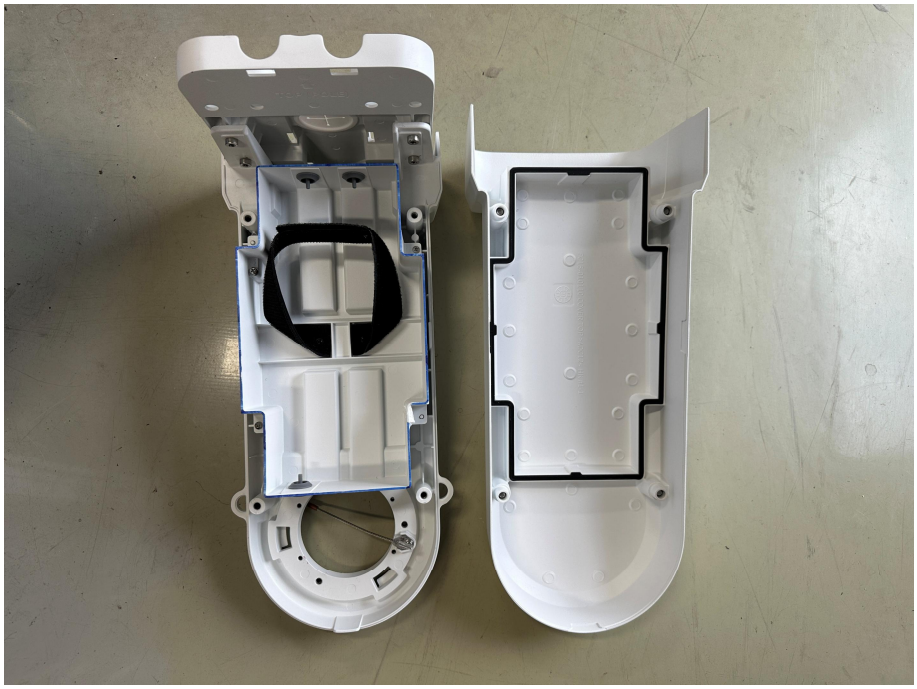
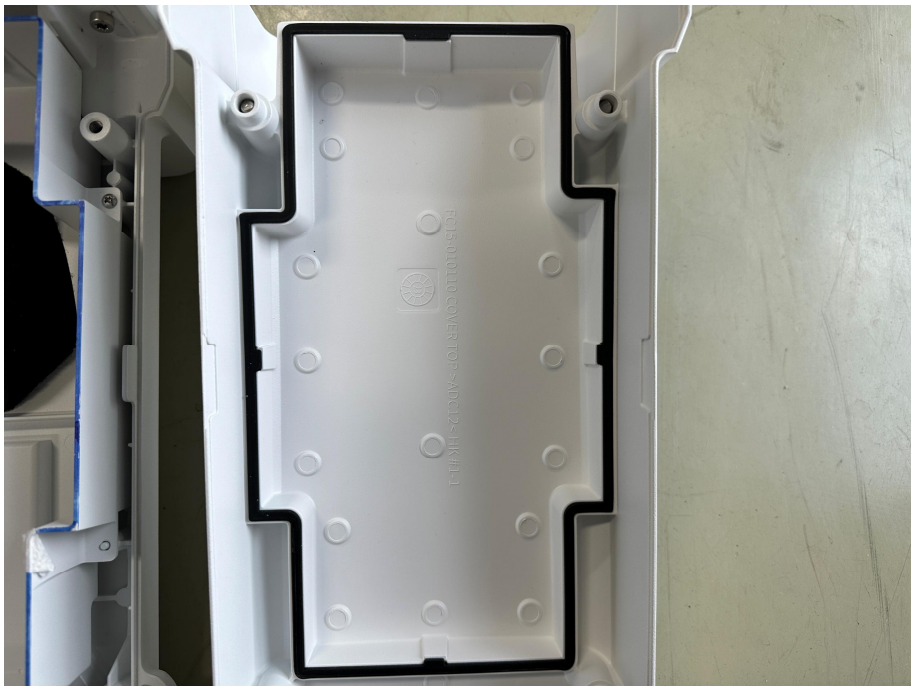
Test Result

Sample No (Model)	Water Flow	Presence of water inside	Result
SBP-400WMW	240 LPM	No	Pass
