# TEST REPORT

REPORT No.:  
CTK-2024-01472  
Page (1) / (13) pages

CABINET / SBP-150NBW

IEC 60529:1989 +A1:1999+A2:2013

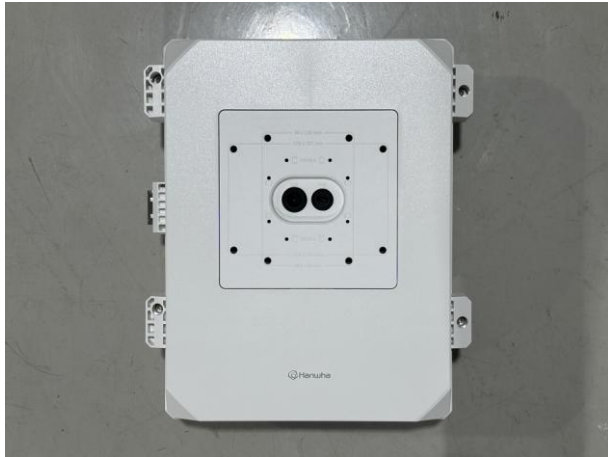
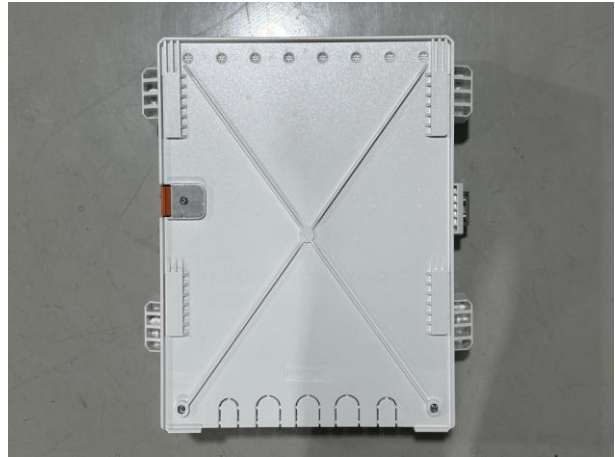
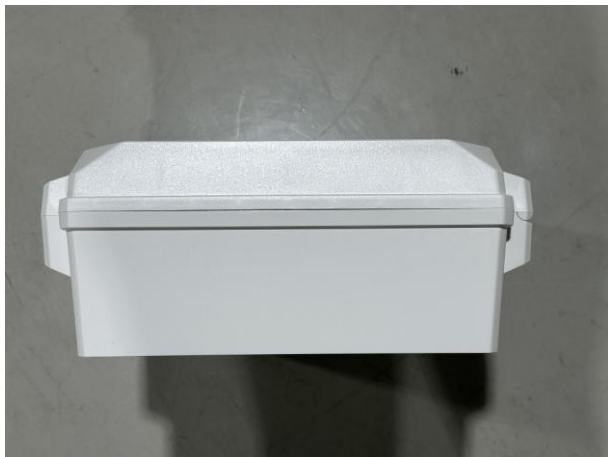
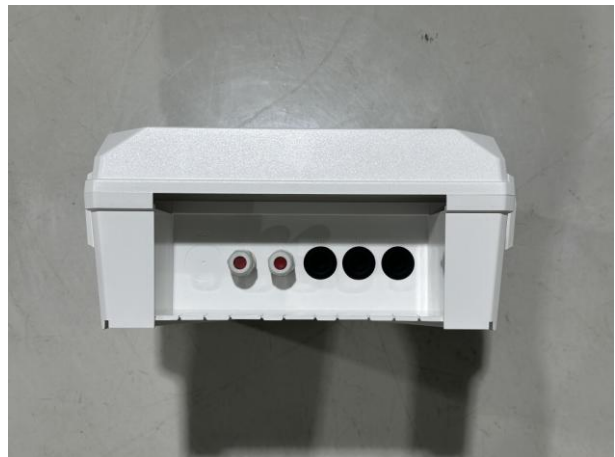
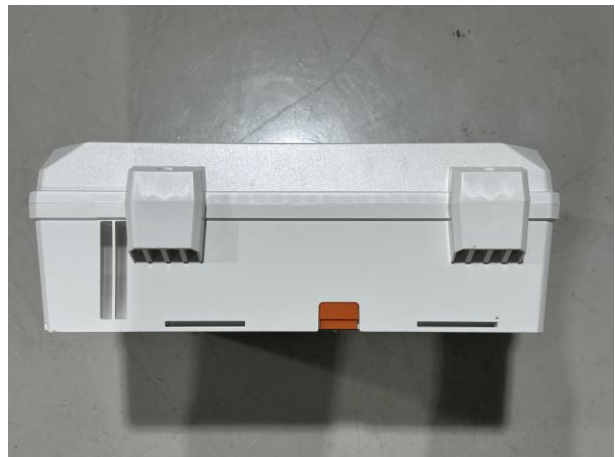
### 2.3 Pre-test product images

Top

Bottom

Front

Rear

Left side

Right side

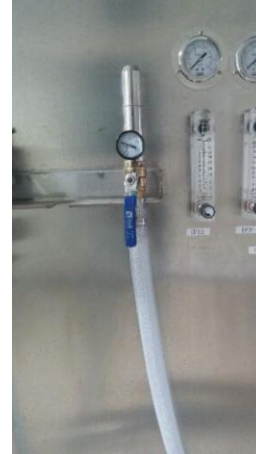
Hose Nozzle (12.5 mm)

Second characteristic numeral	Degrees of protection	Application
6	<p>The product must not be harmed in any direction even strong jet water.</p> <p>Water jet hose nozzle Fig.6, Nozzle 12.5 mm diameter</p> <p>Water flow rate: 100 l/min ± 5 % : <b>100 LPM</b></p> <p>Distance: 2.5 m to 3 m: <b>2.5 m</b></p> <p>Duration of test: 1 min/m<sup>2</sup> at least 3 min: <b>3 min</b></p>	☒

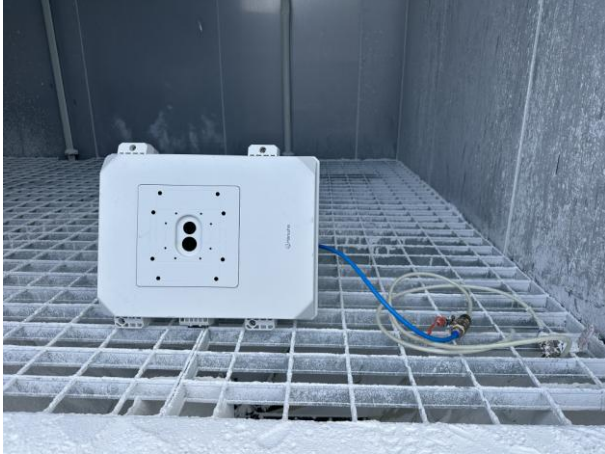
Dust test

First characteristic numeral	Degree of protection	Application
6	<p>In Dust Testing Equipment, the test sample has to have no ingress of dust after testing atmospheric pressure present condition for 8 hr. (Talcum powder have to go through the measured sieve by <math>\Phi</math> 50 um wire that are spacing 75 um in squared, per volume and union Talcum powder have to be 2 kg/m<sup>3</sup>)</p> <p>Products in volume .....: <b>20 160 cm<sup>3</sup> → 20.16 L</b></p> <p>Target intake volume (Products in volume 80) .....: <b>1 612.8 L</b></p> <p>Suction volume (Max product in volume 60) .....: <b>1 209.6 LPH → 20.16 LPM</b></p> <p>Actual Suction volume .....: <b>20.16 L</b></p> <p>Suction pressure (Up to 2 kPa) .....: <b>2 kPa</b></p> <p>Test time (Up to 8 time) .....: <b>8 hr</b></p>	☒

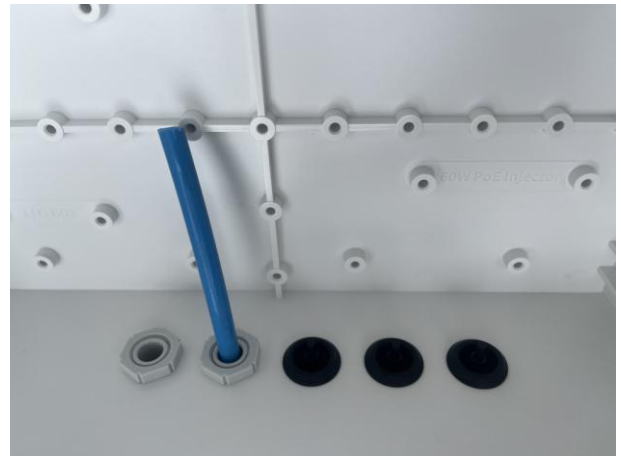
### 4.2.1 Product internal images after test [The First characteristic Numeral Test]

IP code	Evaluation Criteria	Test Results	Remark
IP 6X	No penetration of probe.	Normal	-
	No ingress of dust.	Normal	-
IP X6	No ingress of water.	Normal	-
